HARRY S TRUMAN NATIONAL HISTORIC SITE

INDEPENDENCE, MISSOURI

Historic Structures Report

Restoration Associates  
a division of  
Solomon Claybaugh Young Architects Inc.  
20 West 9th Street Kansas City, Missouri 64105

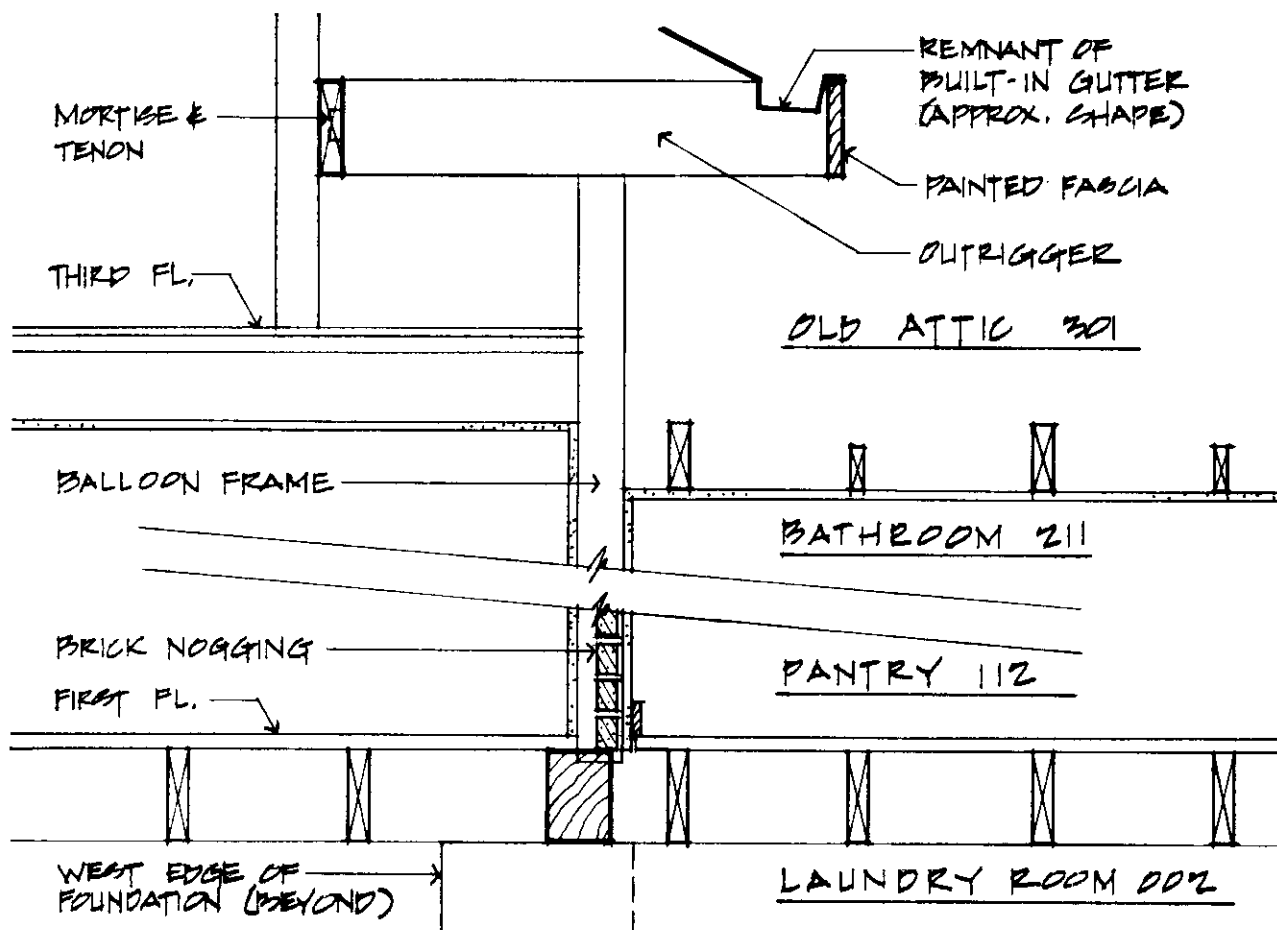
Resembling the massing of a two-story American I-House, the 1867 structure is shown with a medium-hip roof. Recent investigation at the west end of the old attic (301) revealed extant framing of a hip roof with painted fascia board and remnants of a built-in sheet metal gutter. Thus, the east wall of Truman dressing room (209) and hall (208) was originally an exterior wall. The smaller kitchen wing (kitchen 113, pantry 112, butler's pantry 111) is shown with a shallow-pitched, gable roof. A September, 1986 physical investigation revealed that the kitchen wing (113) was balloon framed at the floor joists, north wall. In addition, there is evidence of an intermediate kitchen partition. Presumably, the kitchen wing was constructed as a one-story or one-and-one-half story addition with the roof altered to its existing height and configuration in the remodeling of 1885. (See Fig. 1.2.)

Fig. 1.2 Truman Home. Construction detail of connection between main house and kitchen wing. Credit: Doug Wasama

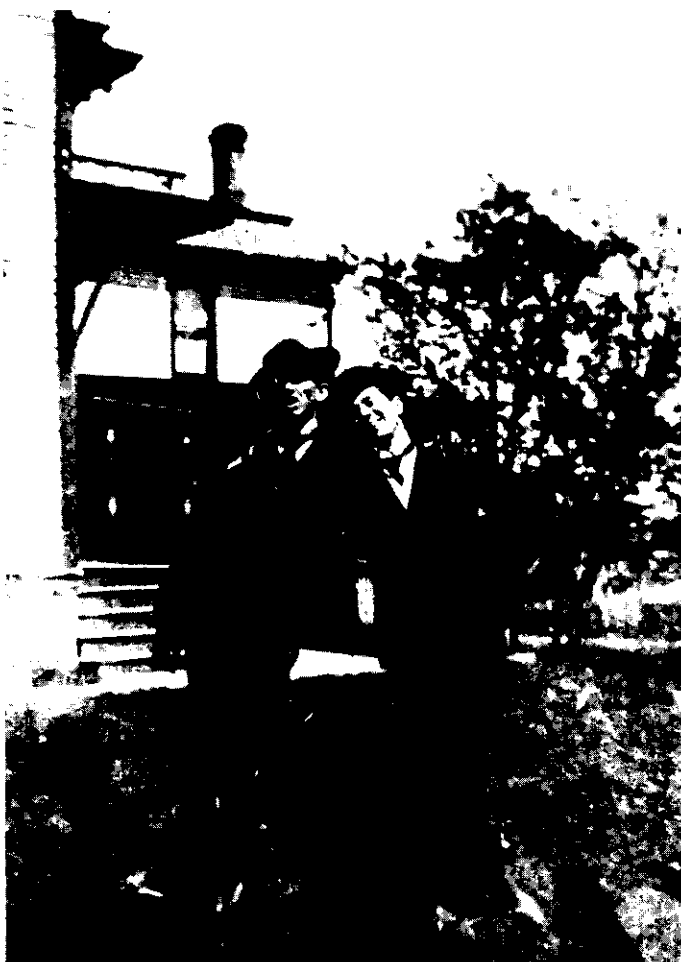
southeast porch (106) was converted into a bathroom. (See Fig. 1.6.) This occurred between 1907 and 1910.<sup>15</sup> In addition, a southeast section of porch was added to kitchen porches 114A and 114B, and a sleeping porch (206) was included at the second-story level.<sup>16</sup>

Fig. 1.6 Truman Home, c. 1900. Southeast elevation (looking northeast). Two unidentified men standing in front of the rear porch that was converted to a bathroom c. 1907-1910. Credit: HSTL

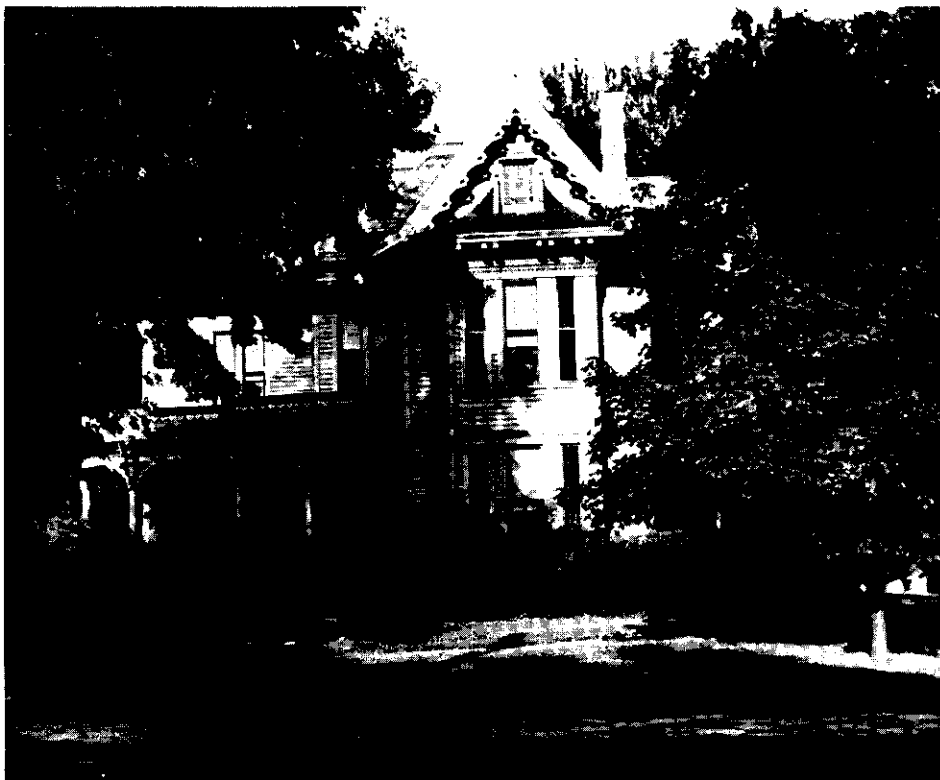
For more than a decade---from the time that Harry Truman won the 1934 Democratic nomination for the United States Senate until 1945 when he became the thirty-third President of the United States---the house at 219 North Delaware was neglected. Although minor in nature, there were several household repairs accomplished, yet by the spring of 1945, the property was in need of major renovation.<sup>20</sup> (See Figs. 1.8 and 1.9.)

Fig. 1.8 Truman Home, July 11, 1944. West elevation (looking east). Before 1945 renovation. Credit: HSTL

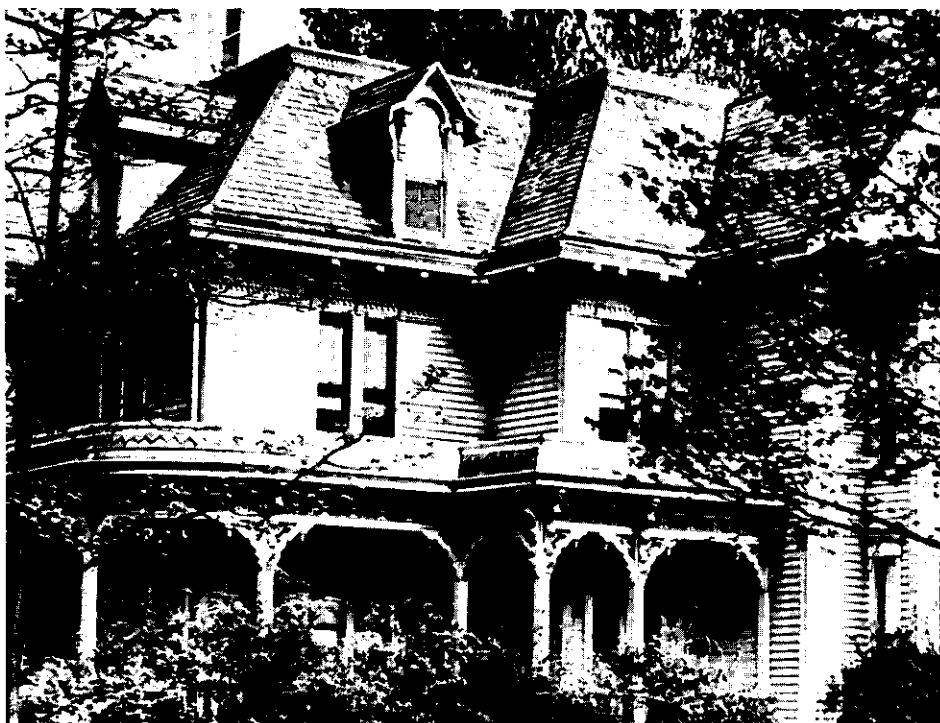
Fig. 1.9 Truman Home, July 22, 1944. West elevation (looking southeast). Detail showing condition of home prior to 1945 renovation. Credit: HSTL

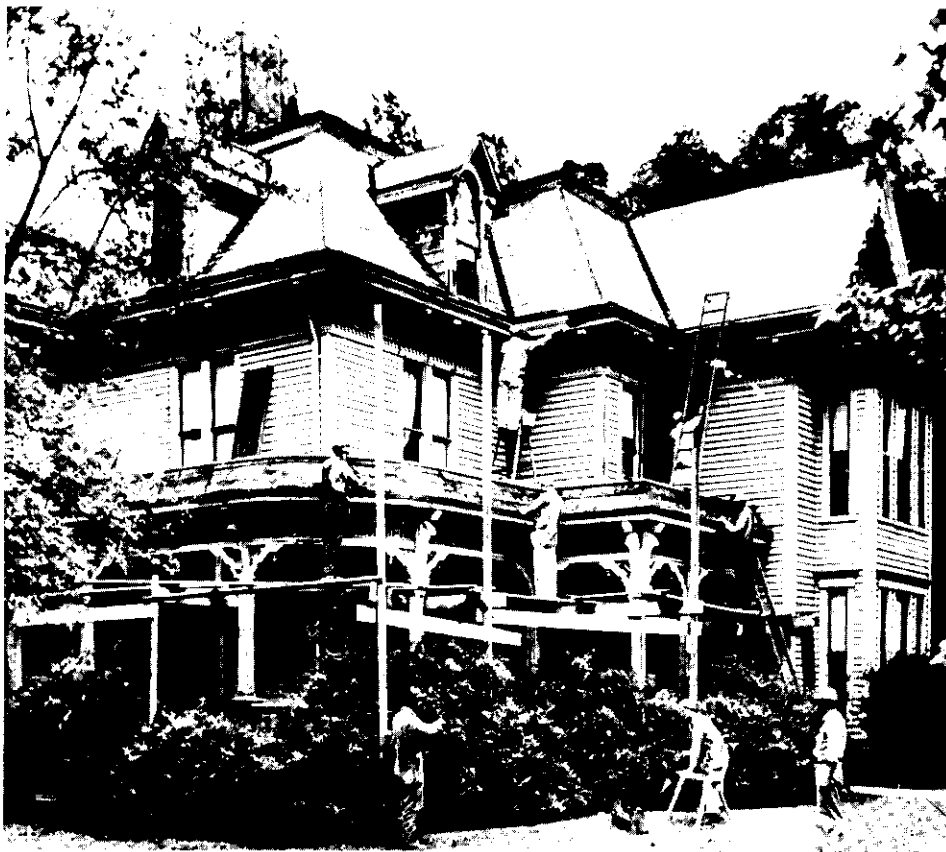
Concerned about the appearance of her family home, Bess Truman made arrangements to begin exterior renovation of "The Summer White House" as it was then called. (See Figs. 1.10 and 1.11.) Work at 219 North Delaware included replacing rotted millwork and slate shingles, covering the worn, grey exterior with white paint, and trim areas with Kentucky green.<sup>21</sup> The second floor bath (211) was also remodeled with a new blue porcelain tub, stool, and sink.

Fig. 1.10 Truman Home, May 21, 1945. West elevation (looking southeast). Workers begin renovation. Credit: HSTL

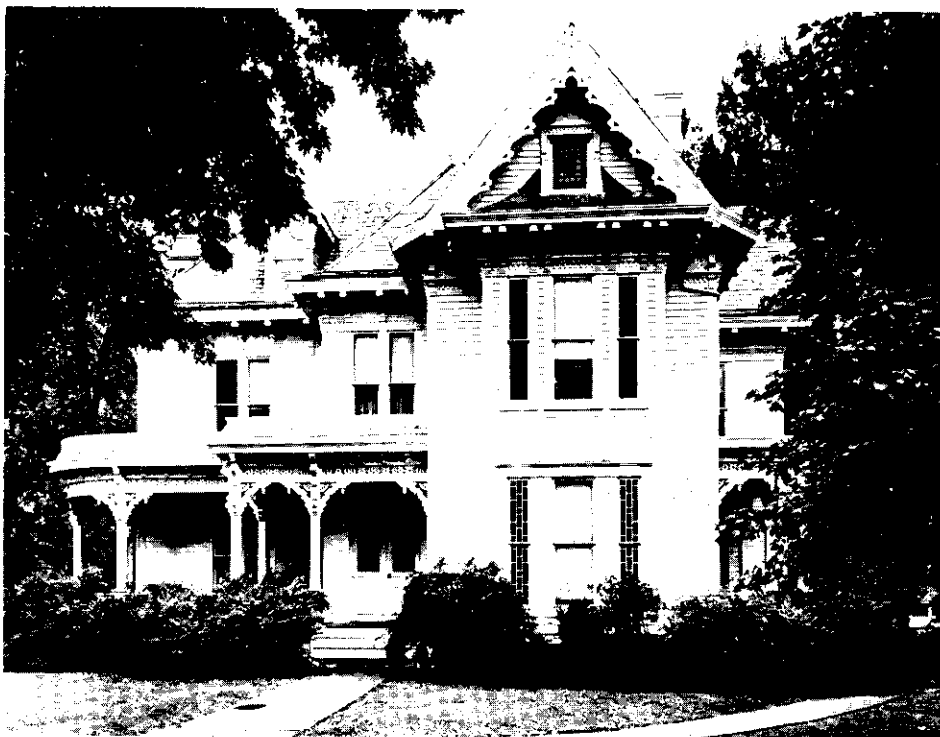
Fig. 1.11 Truman Home, June 27, 1945. West elevation (looking east). After 1945 renovation. Credit: HSTL
